## The “Sabotage Model” or how to find the cause to difficult and mysterious problems: The case of Recovery Boiler compound tube corrosion.

Pentti Soderlin, Management Consultant  
Helsinki, Finland [pentti.soderlin@netlife.fi](mailto:pentti.soderlin@netlife.fi)

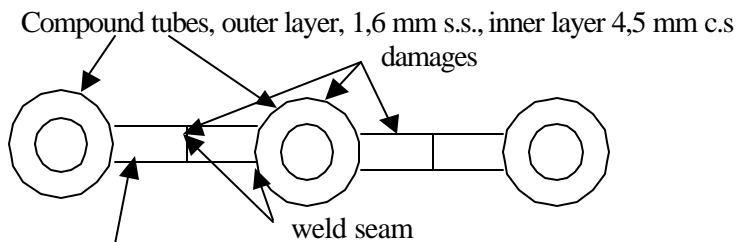
In the mid of 1970's it became customary to build the boiler house of compound tubes connected to each other by fins to form a tight boiler housing. However, later on serious corrosion problems were reported around the world, in the USA, Canada and Scandinavia. This was not related to any particular boiler manufacturer or geographic area but a common feature surprising anybody involved. The damages were in the bottom of the boiler as well as in the air inlet and smelt outlet gutter. Cracks were in

the stainless steel part of the compound tube and in the fins between tubes. The weld seams were also damaged.

The s.s.fins to build tight walls and bottom in the boiler house together with tubing

The recommendation is to give up from 18 % Cr, 10 % Ni low carbon compound tube and to replace the tube by either ferritic low carbon 30 % Cr-lining above c.s. tubing or 30 % Cr-compound tube at the bottom part of the boiler (Cr > 30 %, fire resistant, S-resistant, with Al and Si components or Mo).

The other possibility is to abandon the compound tubing and apply masonry above c.s. tubing to give thermal and chemical shield.
