## The “Sabotage Model” or how to find the cause to difficult and mysterious problems: The case of Recovery Boiler compound tube corrosion.

Pentti Soderlin, Management Consultant  
Helsinki, Finland [pentti.soderlin@netlife.fi](mailto:pentti.soderlin@netlife.fi)

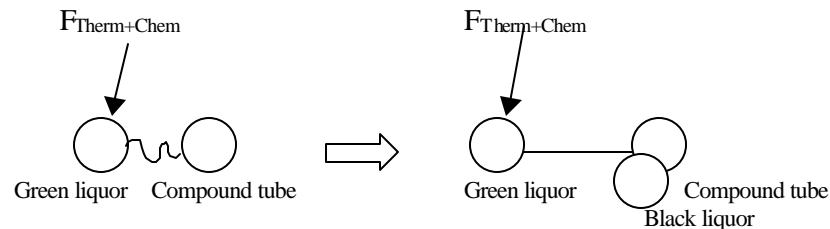
The problem is serious and even those who know TRIZ have been engaged. In Substance - field drawing we have the chemical and the thermal field, the instrument and the object which have unwanted relation. The solution might be simple and understandable: add a substance which in the best case is a variant of the component in question:

However in this case in the trial made the end result was a catastrophe: when black liquor was sprayed on the bottom before the actual burning process was started to “protect” the compound tubing the corrosion was if possible much faster. So the “TRIZ”-solution was not at all a success. How come?
